National Register of Historic Places
Registration Form

historic name Green, Alvin & Annie, House

street & town 8400 Danish Road

state Utah code UT county Salt Lake code 035 zip code 84093

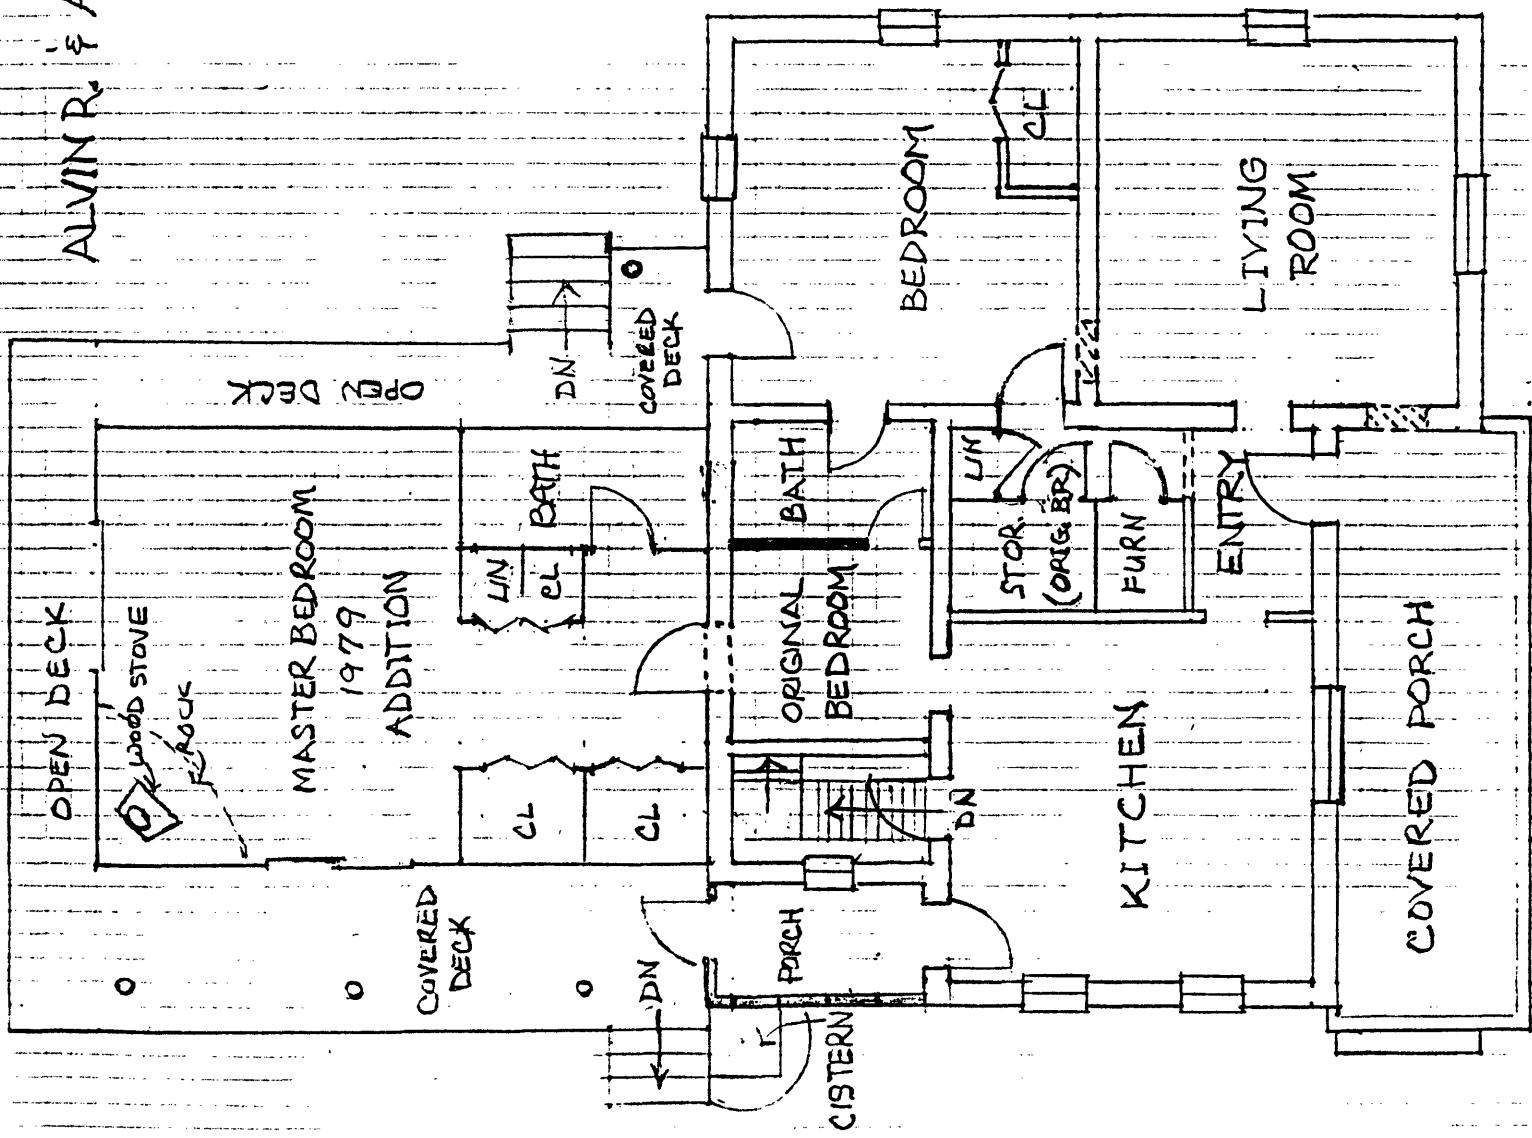
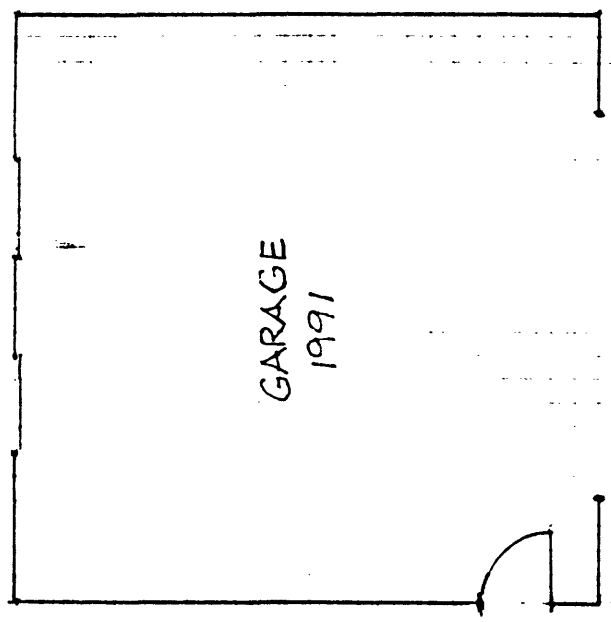
ALVIN & ANNIE GREEN HOUSE

- HISTORIC
- NON-HISTORIC
- 1979 REMOVAL
- 1984 REMOVAL
- 1984 COVERED OVER

SCALE 1/8" = 1'

This cross-wing house originally had five rooms, a living room, kitchen and three bedrooms⁴. It now has eight rooms. An entry hall accessed both the living room and kitchen and still does today. The floors are the original wood tongue and groove flooring. The interior walls are made of two rows of adobe brick and plaster. A stairway from the kitchen accesses a small cellar located under the lean-to extension. The stairwell was lined with shelves used to store the family's cooking and eating utensils. The constantly cool temperature of the cellar allowed the family to store their canned and fresh produce and eggs. The original stairway and cellar are still used today. The attic space is large and could accommodate additional rooms, but was never finished.

The original five-room, cross-wing house, built by Alvin Green, has undergone some interior changes over the years. In the early 1930s electricity was brought into the house. A single light was extended on a cord in the center of each room. Because of the difficulty in running a wire in the solid walls, only the living room had an outlet.

projecting wing had an outside door but no steps were ever built to make it useable as an exit until the deck was added in 1979. The small bedroom off of the main bedroom was used for storage after the children left home. It was later used for a forced air furnace that was installed in 1961.

In 1961 a forced air gas furnace was installed replacing the coal and oil stoves that had been used to heat the living room. Because of the solid granite foundation running through the main part of the house, the air vents had to be installed in the ceilings. At this time, the ten-foot ceilings were lowered to eight feet and the transoms above the doors were covered over.

No further changes were made to the house until 1984. At that time, the walls in the living room and the bedroom were furred out in order to update the electrical wiring. Also, the door between the living room and bedroom was removed as well as the door from the living room to the front porch. A hallway leading to the bedroom was created by dividing the small bedroom/storage room; creating, at the same time, a separate furnace room, a walk-in storage closet, and a linen closet. The three entry doors were replaced with steel case raised panel doors that matched the original doors.
